# Infrared Imaging Radiometry on Bulk Tobacco Barns

FLUE-CURED bulk-tobacco barns have been examined thermo graphically with an infrared imaging radiometer. Regions of considerable heat loss were found to be the pad and the roof, in addition to any cracks or air leaks. Insulation reduced temperature range variations over a barn surface from a range of 50 °C to a range of 10°C.

This article is reprinted from the TRANSACTIONS of the ASAE (Vol. 27, No.4, pp. 1222-1226, 1984).  
Published by the American Society of Agricultural Engineers, St. Joseph, Michigan

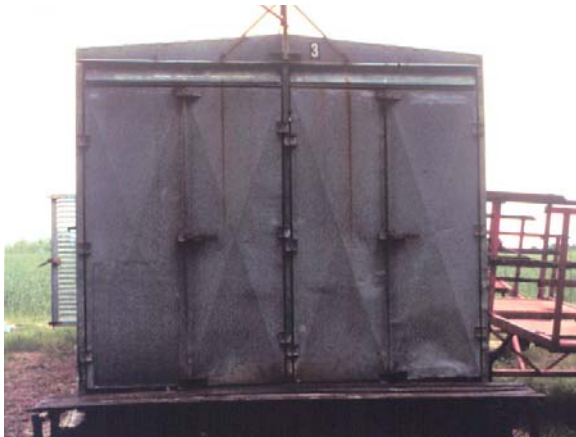
Fig. 1 exemplifies the format for subsequent figures. Fig 1(a) is a normal photograph of an uninsulated tobacco barn showing the loading doors closed. Fig. 1(b) is a thermogram from the same viewpoint of the tobacco barn with loading doors closed. There are various areas of white, different shades of grey and areas of black within the outline of the view. In fact, we are looking at a black and white photograph of a colorized thermogram. That is, colors have been assigned to different temperature regions on the surface of the barn and help to show more distinctly those different temperature regions. If this picture were in color, white would represent areas of highest heat loss, and black would represent temperatures indicating the lowest heat loss. Colors other than white and black would help us determine the temperature of a region relative to a reference surface temperature.

**Fig. 1(a) Normal photograph**

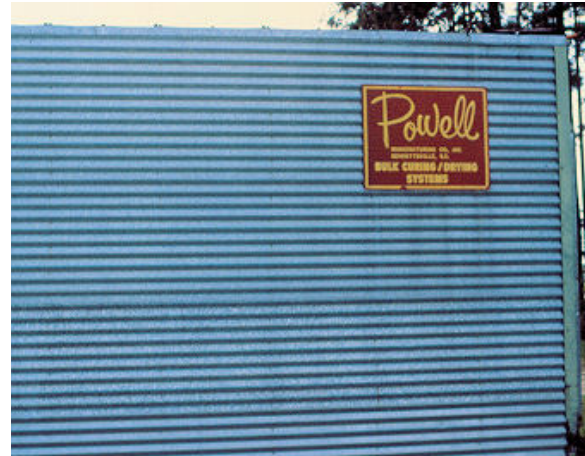
Fig. 2(a) is a regular photograph of the front corner of a tobacco barn and Fig. 2(c) shows that there is some wrap around conductive heat loss from the region in the top right hand corner of the barn on the wall. The specific temperature of this region is 48°C. Corrugations in the side wall surface sheet metal are readily visible on the thermogram. Greater insulation occurs at the peak of the corrugations where the air space is deepest behind the sheet metal. Heat loss is also observed along the eave of the tobacco barn.

Fig. 2(a) Normal photograph

Fig. 2(b) Isotherm contour sketch

Fig. 2(c) Thermogram

Fig. 2 – Views of a bulk tobacco barn uninsulated sidewall adjacent to the loading doors.

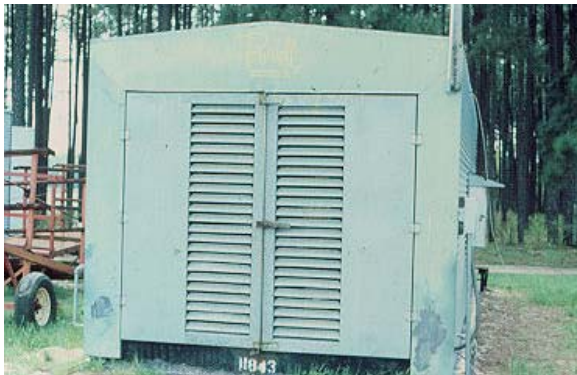
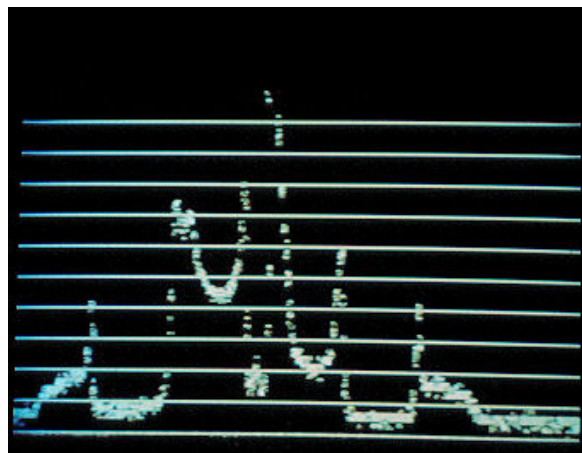
the barn. As seen in the normal photograph, the doors of the furnace room are closed and yet the thermogram indicates that heat loss is in fact taking place through those doors. Other areas of loss are the ducting region above the doors and the back wall below the doors.

Fig. 3(c) indicates temperatures as high as 55°C observed over certain areas of the barn. The line scan in Fig. 3(d) highlights the edges of the furnace room doors and also the burner of the furnace itself in the center of the picture. Of course, the burner is obscured from view in the normal photograph. Yet, we know that it is there from the thermogram. This is a good of thermography as a detection tool. In this case, the temperature on the line scan at the location of the burner goes beyond the scale being used at this specific time on the scanner. Bringing the burner temperature back into view would also change the scale relationships of different regions in the rest of the picture.

**Fig.3 (a) Normal photograph**

**Fig. 3(b) Thermogram**

**Fig. 3(c) Isotherm contour sketch**

**Fig. 3(d) Line scan**

**Fig. 3 – Views of the furnace end of an uninsulated bulk tobacco barn.**

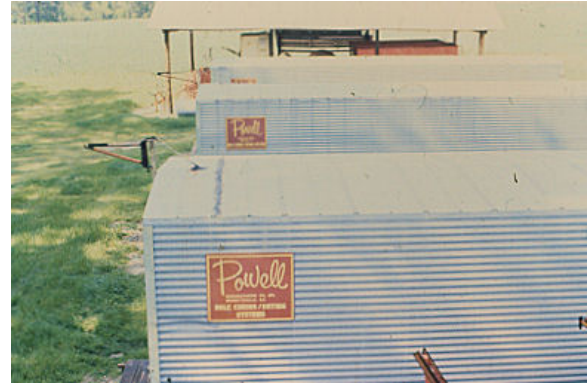
The normal photograph in Fig. 6(a) is taken looking down upon the roof of the specific barn being observed. Focusing our attention on the first barn in the foreground of the photograph, the thermogram in Fig. 6(c) has lighter areas to the left hand side and darker areas to the right hand side of the barn roof. We are demonstrating here the importance of insulation in the roof of a barn. There is no insulation in left hand section of the barn roof. However, there is one inch of polystyrene foam material in the right hand side section of the roof. The surface temperatures of the roof according to Fig. 6(b) are 45°C at the uninsulated area and only 37°C at the insulated area. The heat loss from a tobacco barn can thus be reduced by roof insulation.

**Fig. 6(a) Normal photograph**

**Fig. 6(b) Isotherm contour sketch**

**Fig. 6(c) Thermogram**

**Fig. 6 – Views of the roof of a bulk tobacco barn which is partially uninsulated.**

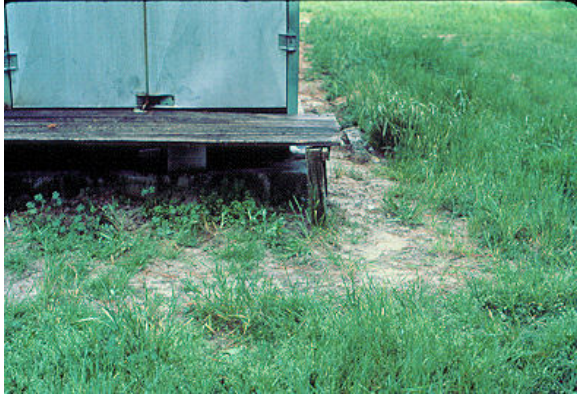
The concrete pad of a tobacco barn, if one is in existence at all, is pored immediately onto bare earth. Tests have shown that up to 5.6 percent of total fuel consumption can be attributed to losing heat through the pad on which the barn is resting (Chang et al., 1979). To give some indication of this heat dissipation we refer to Fig. 8, where we are looking at a corner of the barn. Here the barn is visibly in direct contact with the ground. The thermogram displays a very clear dissipation of heat from the barn into the soil. Contact temperatures taken of the soil specific distances away from the barn indicate a temperature rise from 26°C through 38 °C at the surface of the barn. Soil temperatures away from the barn were only 24°C. This heat loss into the soil is a good justification for including some insulation materials in the concrete while it is being laid. Special attention should be given to the edges of the concrete, where it appears much of the heat loss takes place.

**Fig. 8(a) Normal photograph**

**Fig. 8(b) Isotherm contour sketch**

**Fig. 8(c) Thermogram**

**Fig. 8 – Views of the concrete pad-soil contact region for a bulk tobacco barn.**
